No Hitchhikers allowed:

By: Tim Clancy

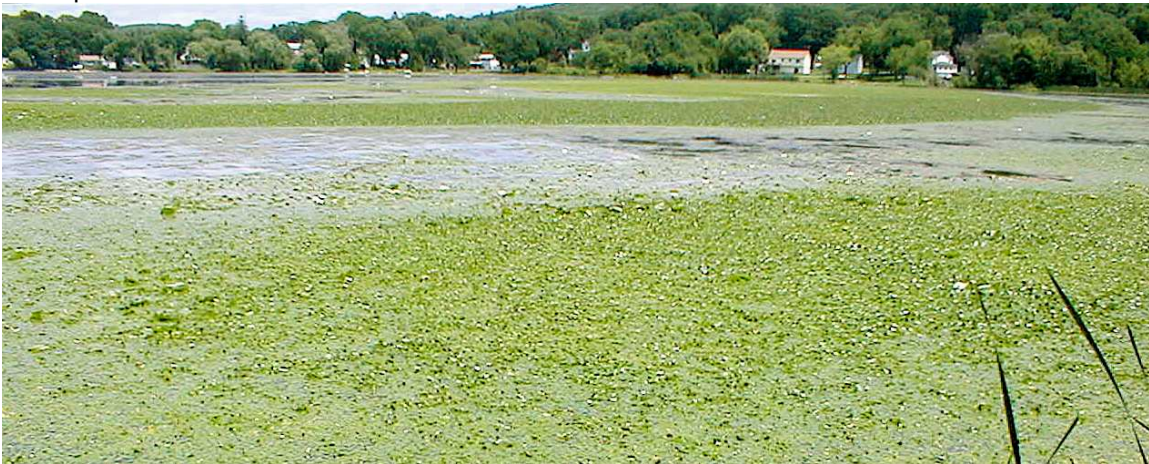
As a floating aquatic it can block out nearly all sunlight. That displaces other more desirable native plants, which can result in fish kills from depleted oxygen level and also facilitate algae blooms. Look at this photo taken at Lake Musconetcong and imagine trying to boat, swim, fish, ski or sail in a cove where this plant has become well established.

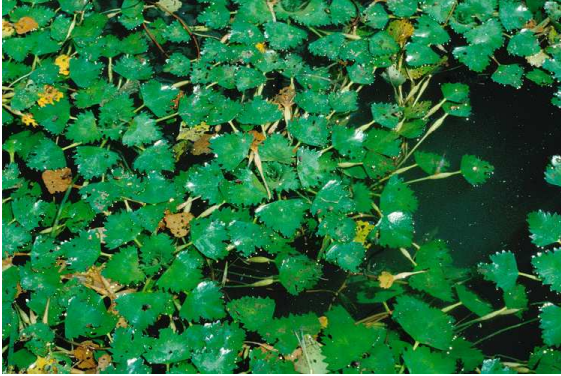
Water Chestnut is a floating aquatic with a triangular shaped leaf that is sharply serrated along both sides but the best way to distinguish from other similar floating aquatics is that the individual leaf is relatively small in size, generally less than 2 ½ inches wide. It quickly grows into a large mass of weed, blocking out sunlight, which can have a multitude of negative impacts on the environment. It also makes any recreational use of the area nearly impossible, so we really need to work together and not let this plant specie get established here at Lake Hopatcong.
